Service Instruction

ENGINE COMPONENTS, INC.

S.I. No.: 07-2

Title: Crankcase Anti-Seep Grooves

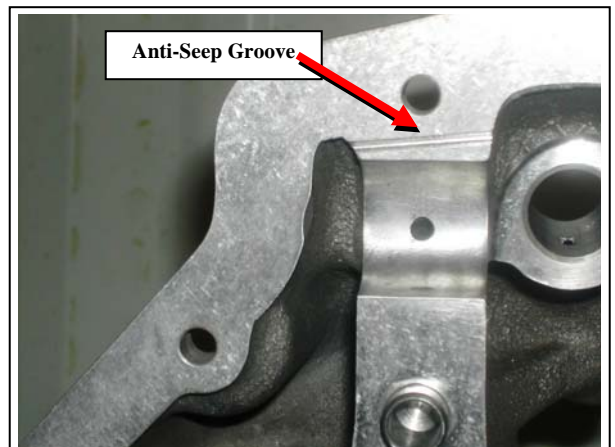
Photograph 1

Indicates the anti-seep groove above the front cam bearing boss of an ECi FAA PMA Replacement crankcase for Lycoming engines.

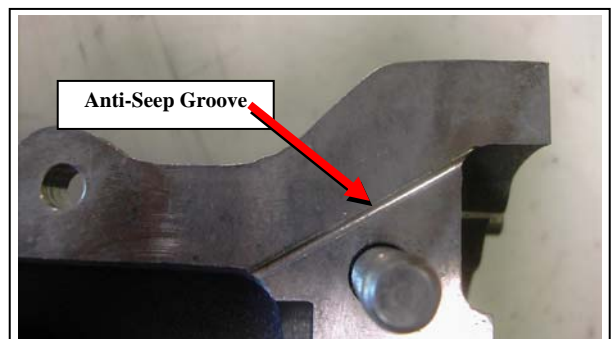
Photograph 2

Indicates the anti-seep groove at rear main of an ECi FAA PMA Replacement crankcase for Lycoming engines.
